RCRA PRIORITIZATION SYSTEM SCORING SUMMARY

DURA-BOND STEEL CORPORATION

EPA SITE NUMBER: FLD-982-168-072

JACKSONVILLE, FL

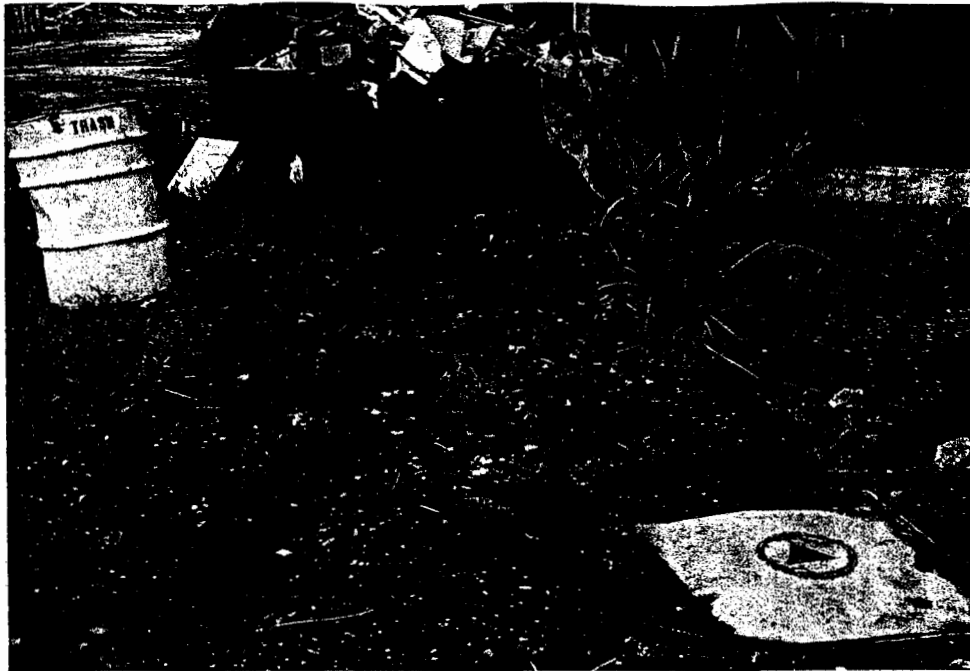
2.1 Facing north at the Area Immediately Adjacent to Dumpster (SWMU 2). Note monitoring well No. 7 is located in the foreground. The brown box in the background is the Dumpster (SWMU 22). (1-13)

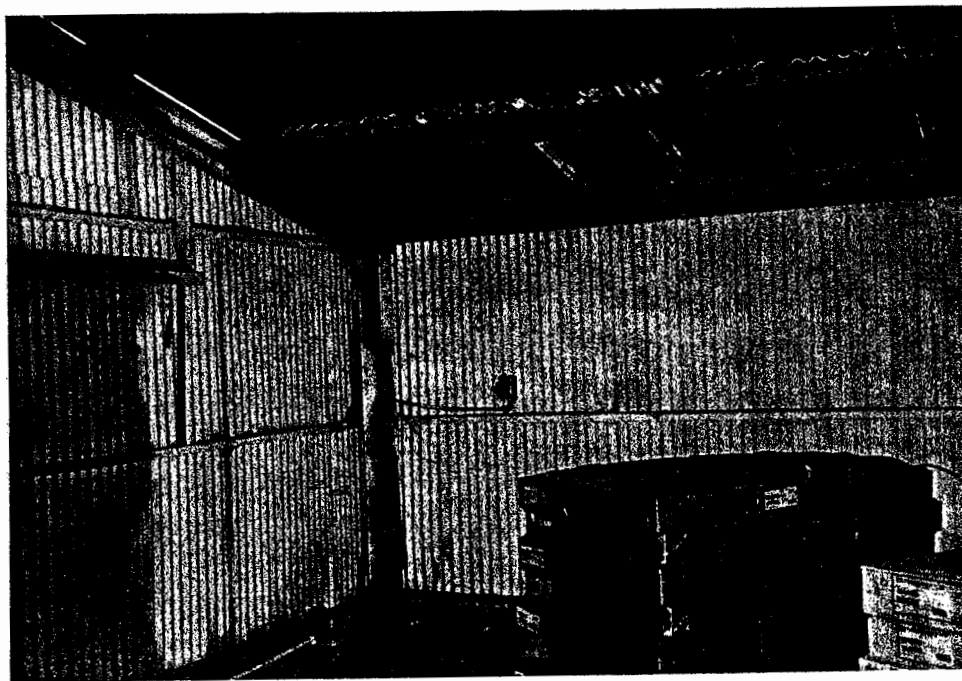
- 4.1 Hazardous Material/Waste Storage Area (SWMU 4), facing west. A solvent recovery unit was formerly located in the corner. Note that the pad is not curbed or diked. (1-16)

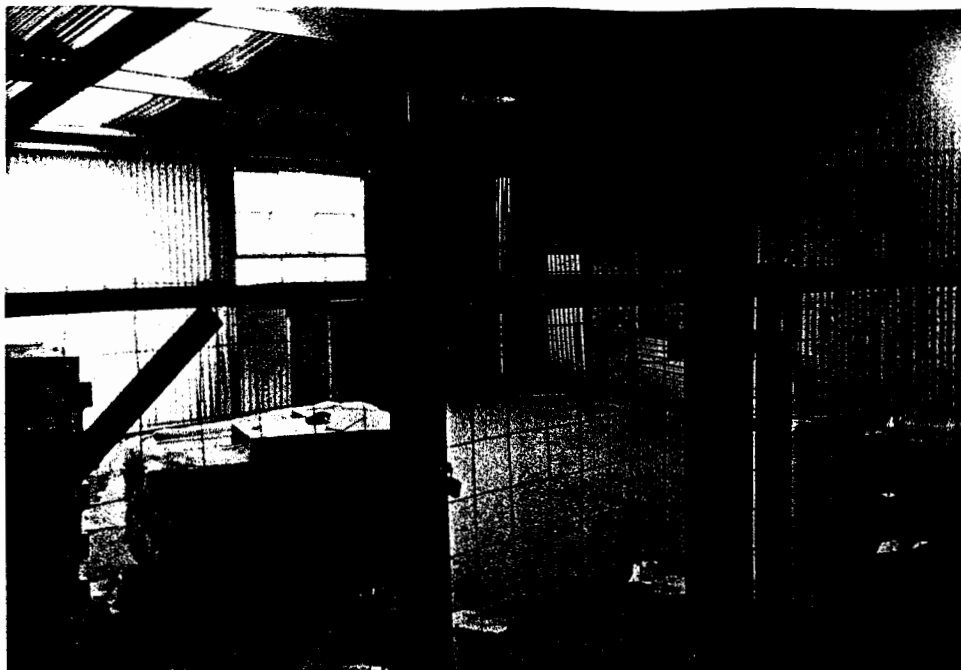
4.2

Facing northwest at the Hazardous Material/Waste Storage Area (SWMU 4). Note welding rods are now stored in the area. (1-17)

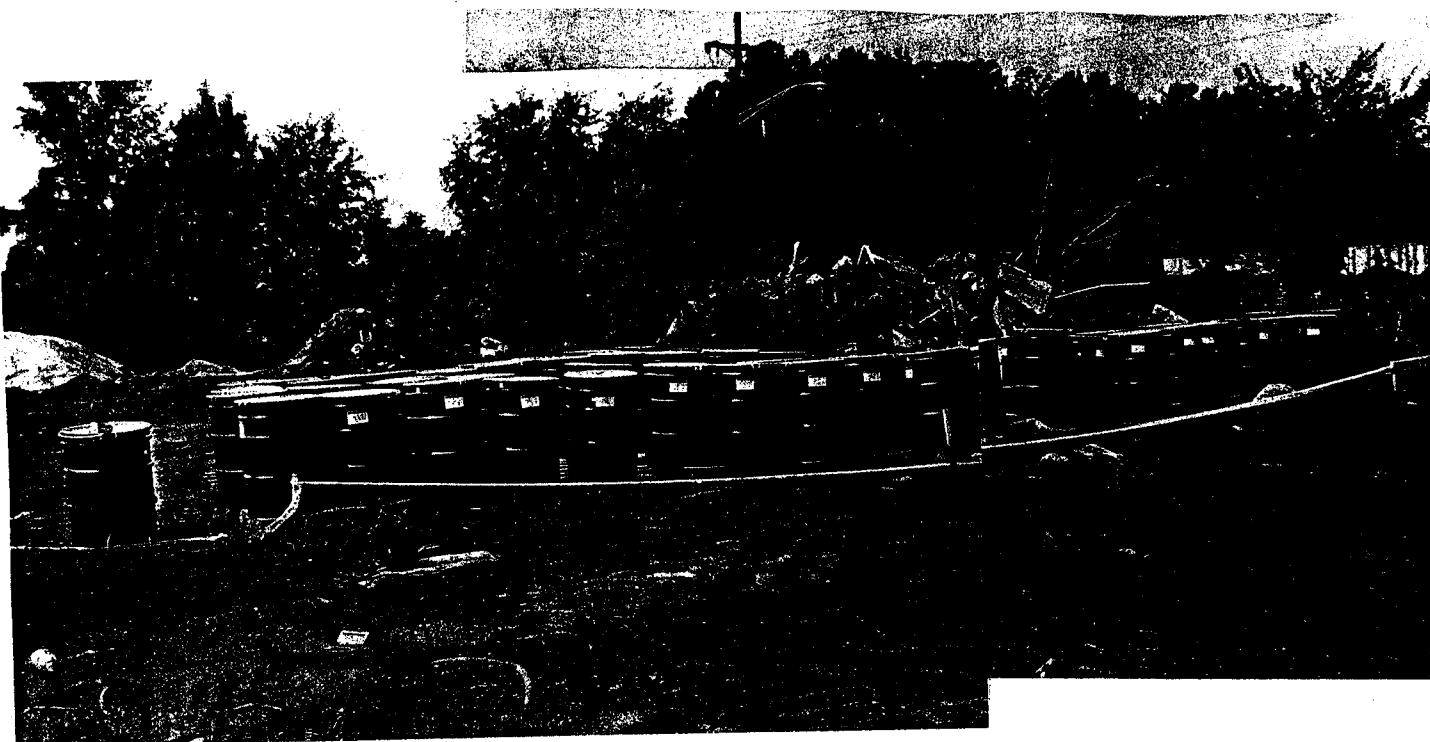
- 12.1 Overview of the Paint Can Excavation Drum Storage Area (SWMU 20), facing southwest. Note that most of the drums are positioned on wooden pallets. The drums contain visibly contaminated soil from the Paint Cans Excavation Area (SWMU 12). The Construction Debris/Soil Pile (SWMU 21) in the immediate background was created during construction activities for the new painting building. (1-33, 1-34)

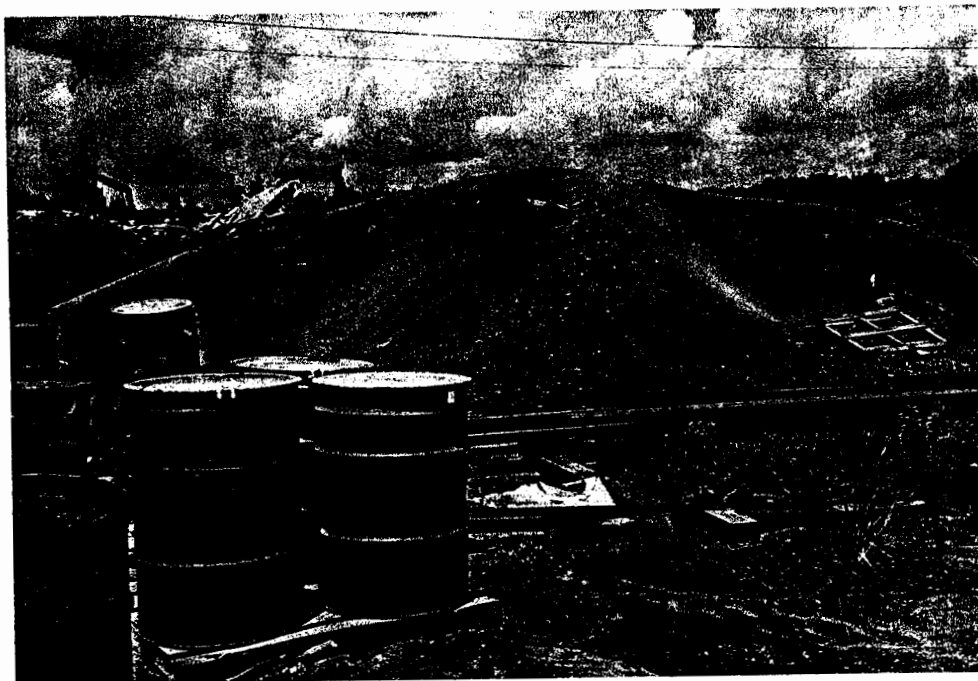
16.1 Overview of the Sandblast Area (SWMU 16), facing northwest, with the drums of shot blast dust in the foreground. (2-30)

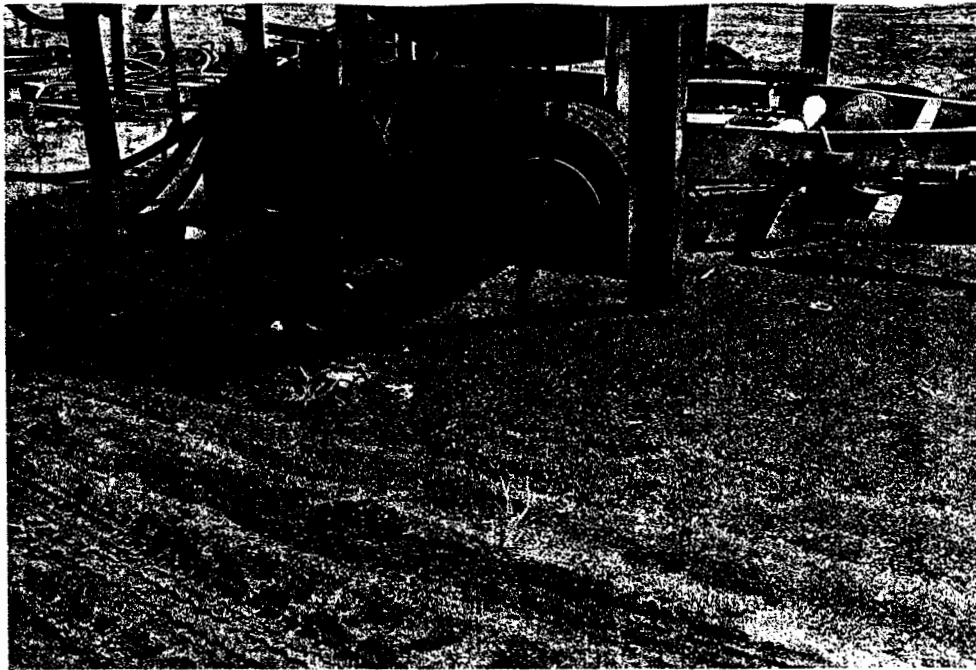
16.4 Area beneath the sandblaster at the Sandblast Area (SWMU 16), facing northeast. Note there appears to be Black Beauty™ residue on the ground. (2-28)

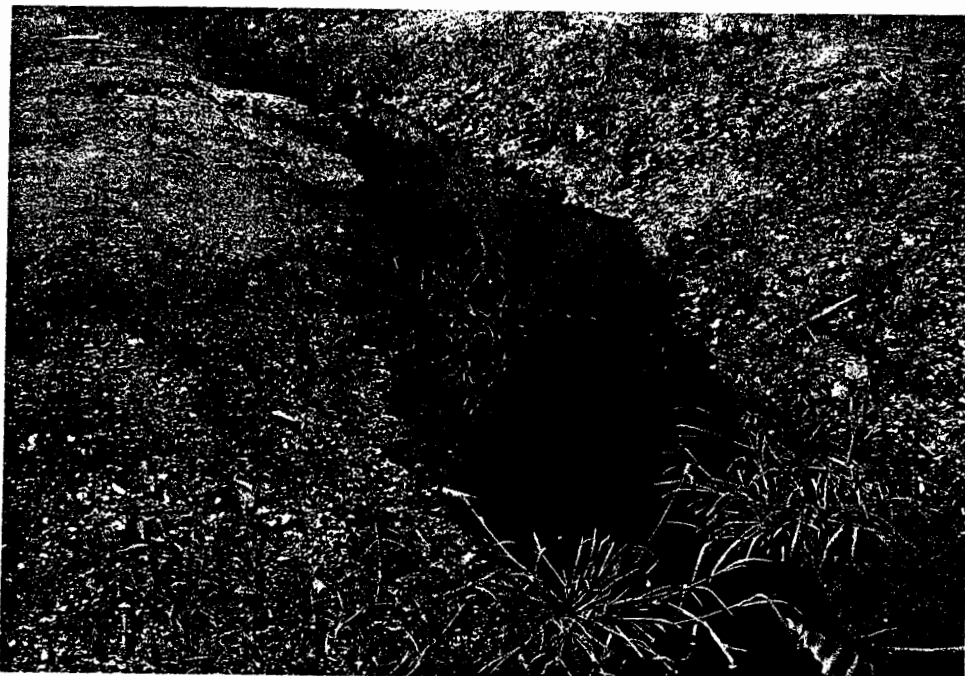
19.3 View of Drainage Ditch (SWMU 19), facing northeast. This portion of the unit is located to the east of the main facility building, upstream from the Ramp Area (SWMU 7) and downstream from the Wheelabrator Dust Collector (SWMU 5). There is a small hose in the center of the photograph which discharges ground water collected in the Wheelabrator Sump (AOC C). (2-16)

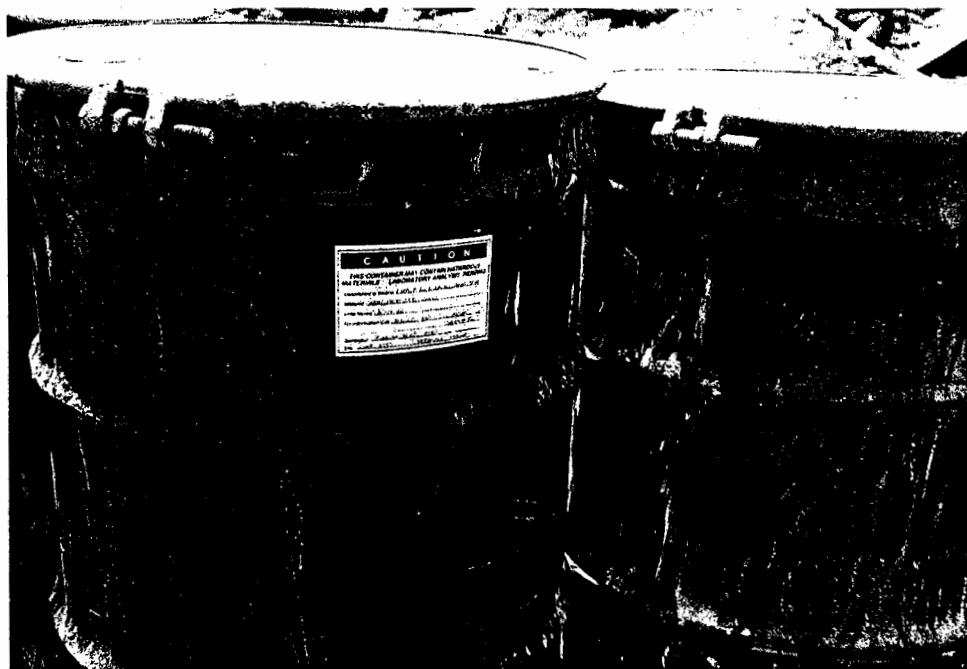
20.1 Close-up of the drums in the Paint Can Excavation Drum Storage Area (SWMU 20), facing south. The label indicates that the container may contain hazardous materials and that laboratory analyses are pending. (2-25)

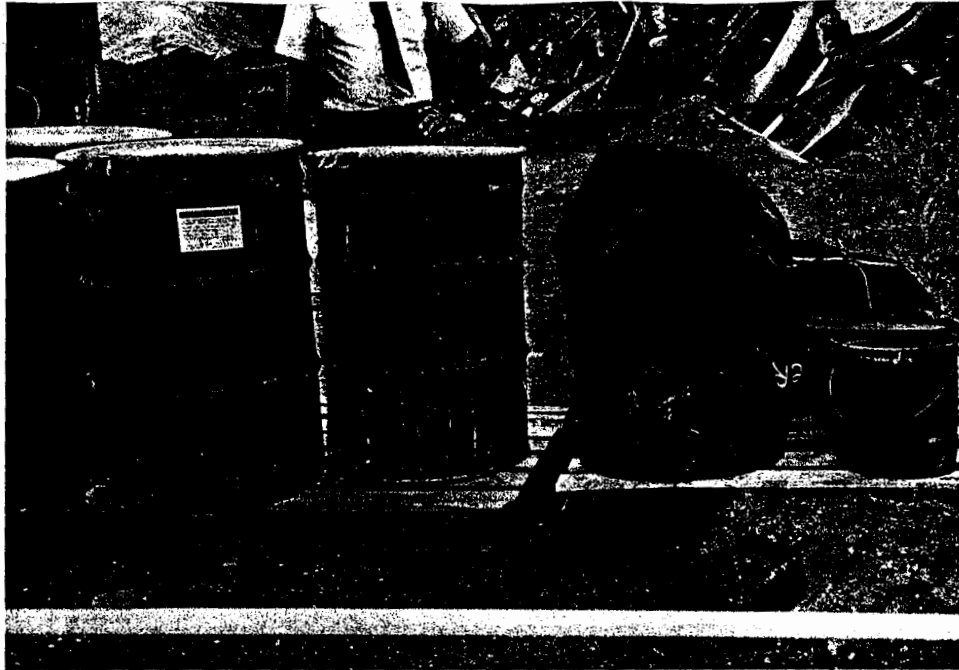
20.2 View of old and crushed drums at the Paint Can Excavation Drum Storage Area (SWMU 20), facing south. (3-11)

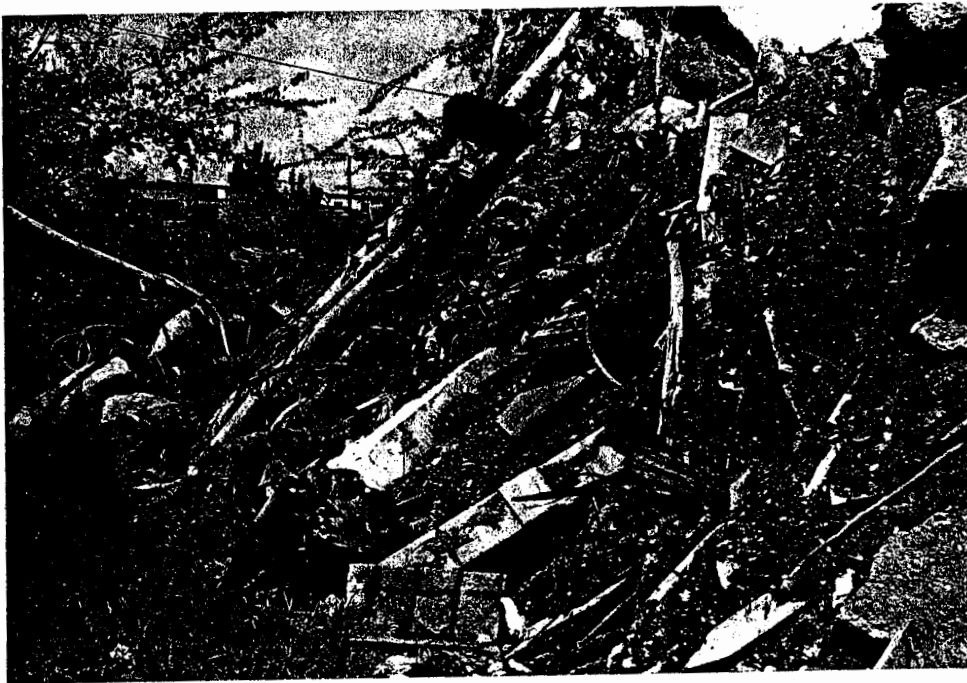
21.1 Close-up view of the Construction Debris/Soil Pile (SWMU 21), facing west. Note the crushed drum in the left foreground. (2-24)

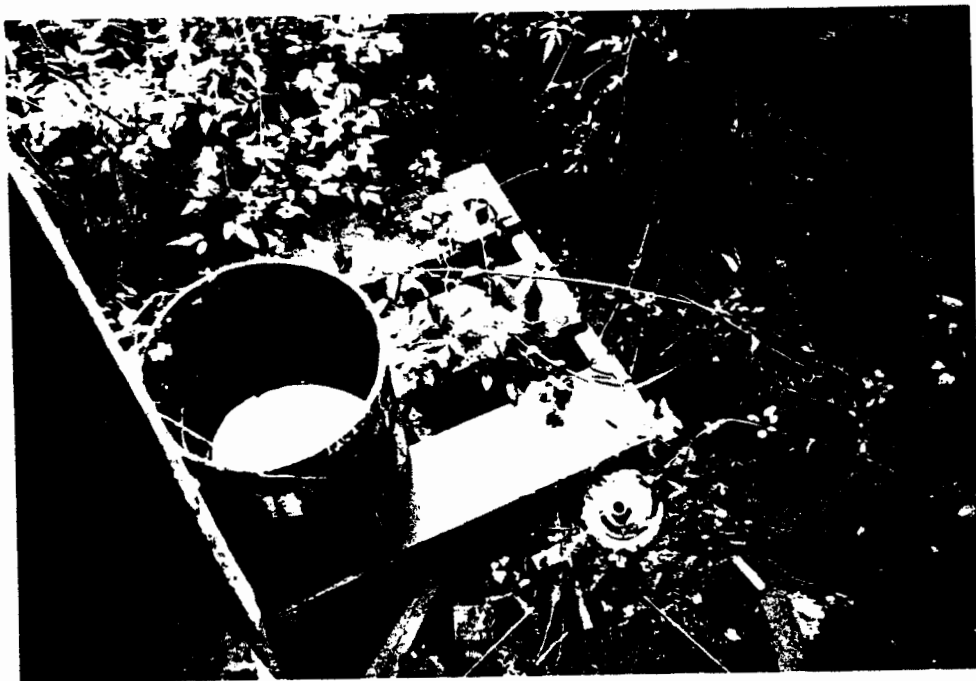
1.6 View of the Area Adjacent to West Side of Facility Building (SWMU 1), facing south. Note the bucket on the pallet appears to and reportedly contains paint waste containing methyl ethyl ketone (EPA Waste Code F005). The soil appears to be stained and the vegetation is stressed.

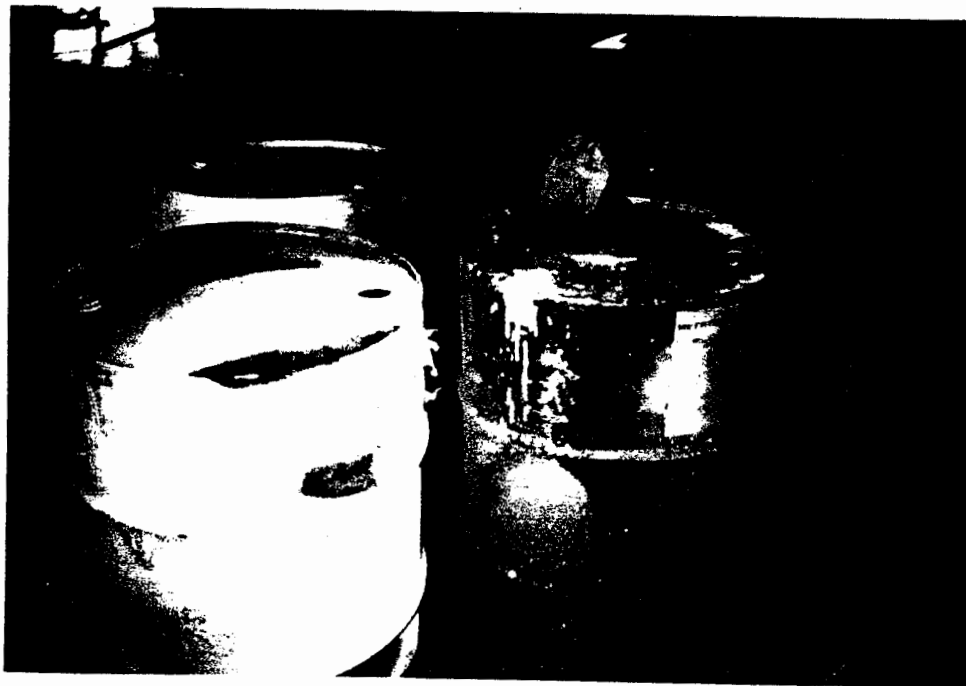
4.4 Close-up of drums containing methyl ethyl ketone waste located adjacent to the Hazardous Materials/Waste Storage Area (SWMU 4), facing west.

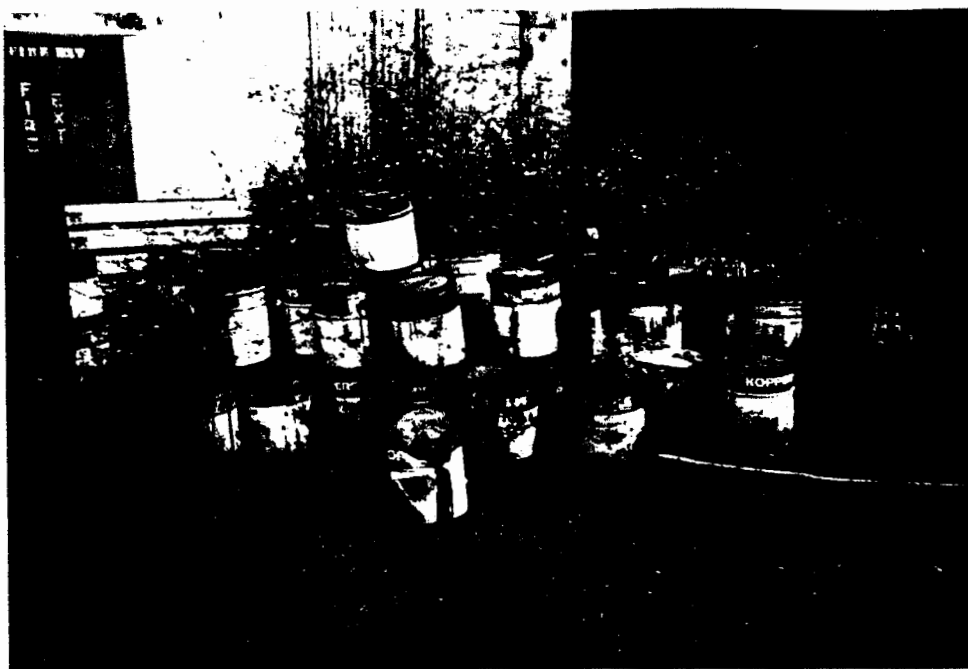
10.4 View of the area outside of the Blue Shed (SWMU 10), facing an unknown direction. Note the can in the foreground is crushed and some material (possible coal tar) has leaked from the can.

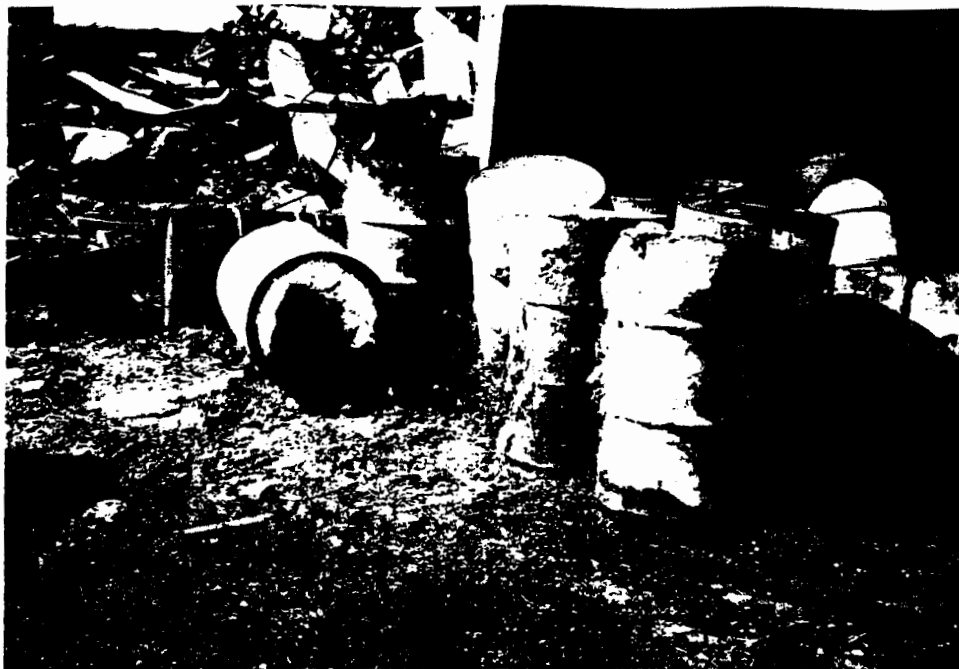
11.1 View of the Sheet Metal Building (SWMU 11), facing an unknown direction. Note the drums appear to be in poor condition.
